Achievement: Optimization of DCVG electrode position

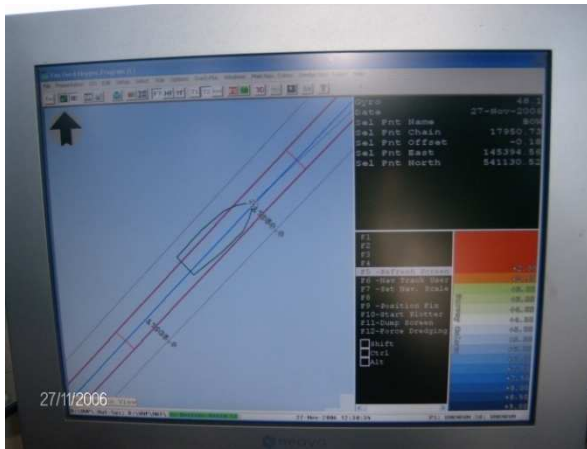
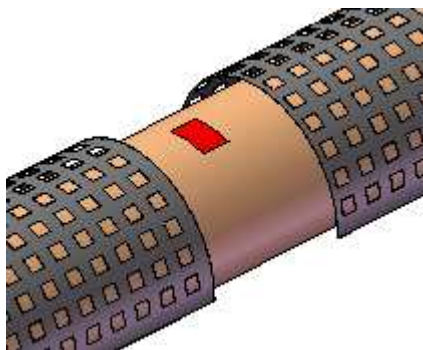
- **Issue:** Neighboring coating defects on submerged pipeline can mask each other due to presence of reinforced concrete coating
- **Solution:** Elsyca studied different DCVG electrode positions and configurations in order to optimize DCVG survey
- **Results:**
 - Prove of masking of neighboring coating defects due to presence of reinforced concrete has been given
 - Optimal DCVG electrode spacing and position has been established
